OFFICIAL TEST REPORT

# STONEFACE LTD & CERTIFIED STONE PLUS LIMITED AS/NZS 4284

Shelby Wright Test Report

| Client Information | |
|---|---|
| Project Name | STONEFACE Ltd & CERTIFIED STONE PLUS LIMITED – AS/NZS 4284 |

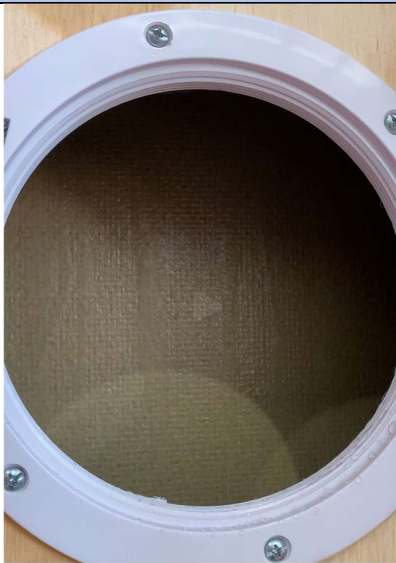
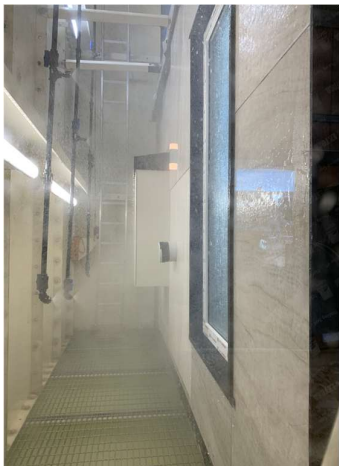
| Obs. No: | Test | Observation | Photo |
|---|---|---|---|
| 1 | All water penetration tests | <p>Due to the ventilated façade design with open horizontal joints between UCS modules, water was observed running down the inside face of the UCS.</p> <p>As there are no horizontal elements in the STONEFACE mounting systems, no water was directed to, or was observed to migrate to the Adhero membrane.</p> <p>The water on the inside face of the UCS was managed and exited the façade cavity at the lower interstorey junction.</p> | |

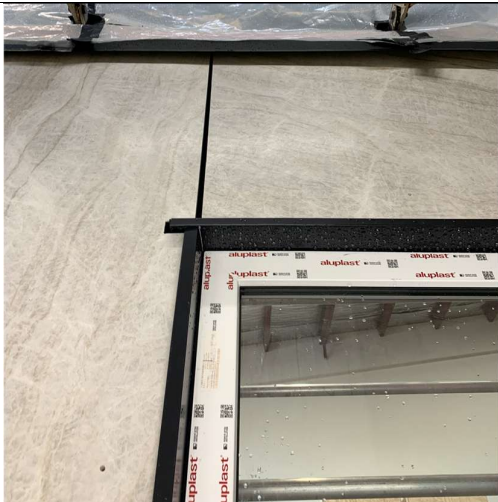
| 2 | Seismic SLS | The mechanically fixed components/UCS modules demonstrated significant closure and opening of gaps between stone module, whereas the UCS modules mounted via the chem-elastic systems showed very little movement relative to adjacent modules, with the gaps maintaining a relatively even distance throughout the seismic cycles. | |

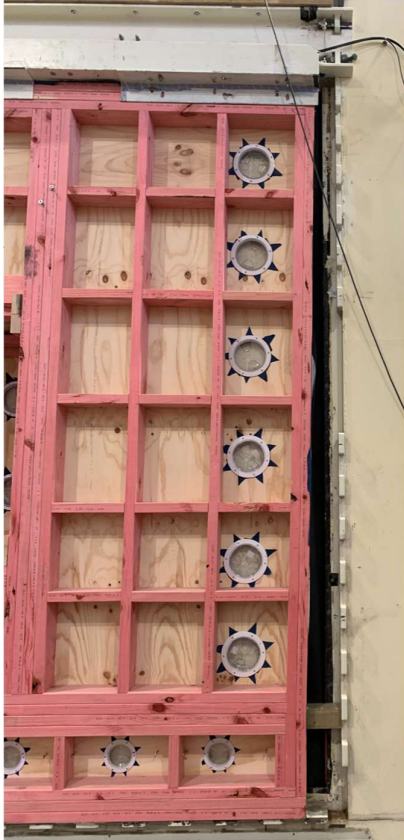
| 3 | Seismic ULS | Image showing the extent of seismic racking | |

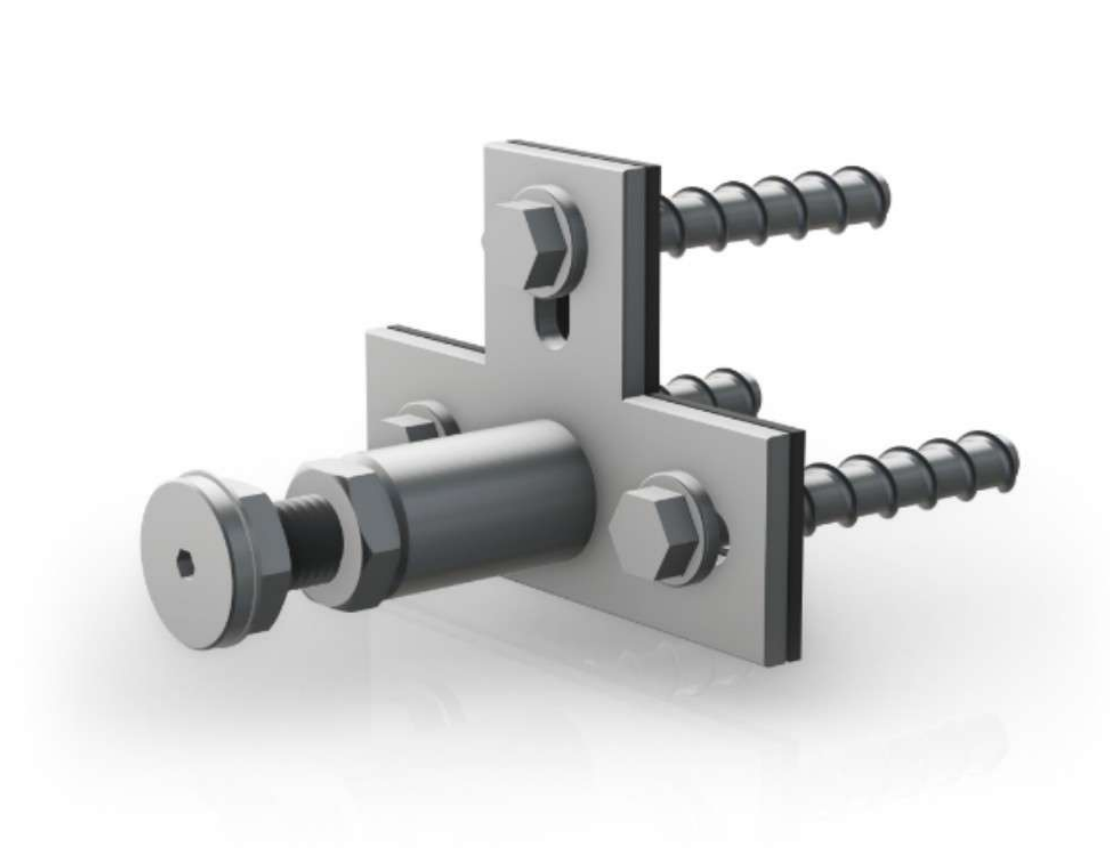
**STONEMEC CAVITY EXTENSION BRACKET**

Cavity Depth 120-245 mm

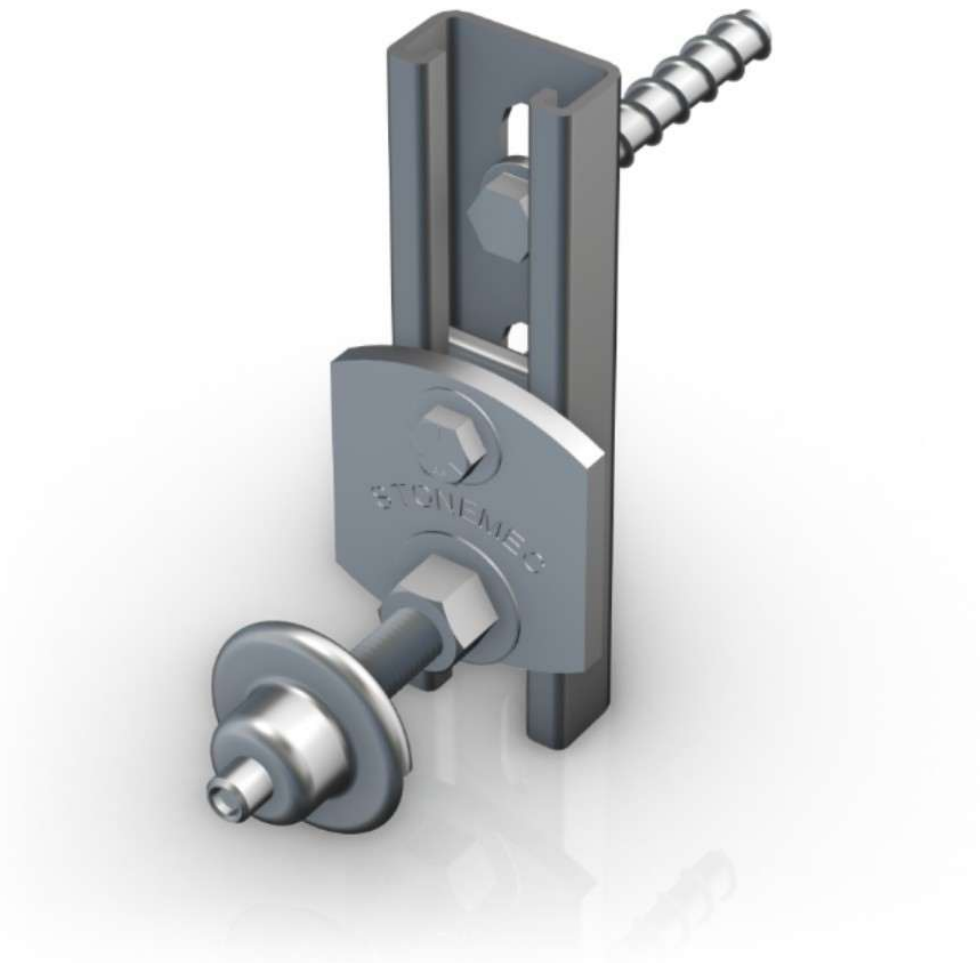
**STONEMEC Plus Fischer Type Anchor - Natural Stone**

Cavity Depth 70-145 mm
